CASE STUDY

REVIVING A 77-YEAR-OLD TERRAZZO FLOOR

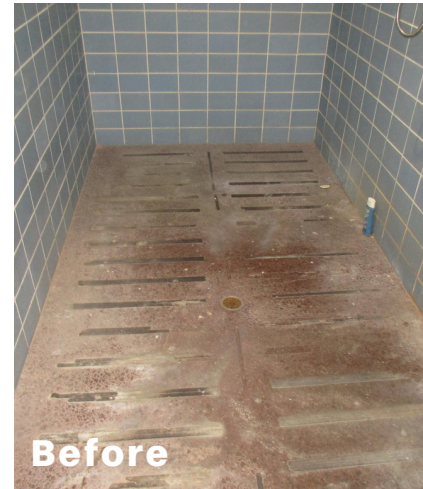
Before

The floors had accumulated over 40 layers of acrylic finish which needed to be stripped off. Nick Blakenship, with Titan Exterior Surfaces, brought in heavy-duty grinding equipment to remove all the existing finish. Titan applied a thin coat of MC Epoxy to prime the floor and fill in some of the pores. To improve safety in the shower areas, a coat of Ultra HTS urethane was applied to enhance slip resistance without compromising the floor's appearance. Nick said, "The Ultra Terrazzo system provided by Ultra Durable Technologies flowed seamlessly and delivered excellent results. We're extremely pleased with the outcome of this project."

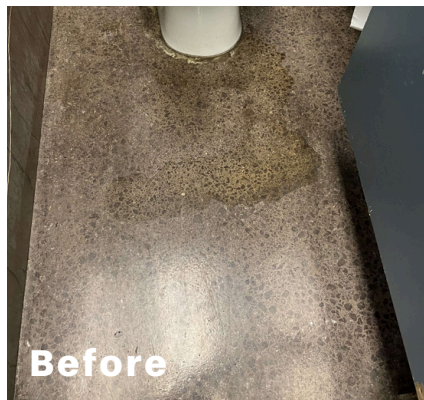
Before

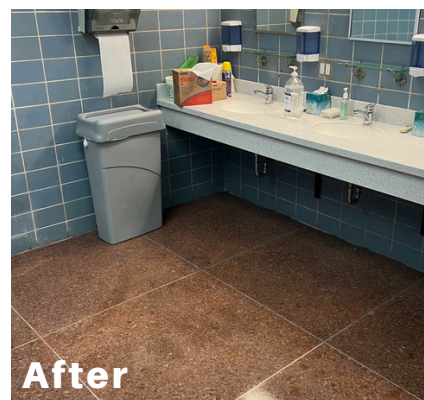
After

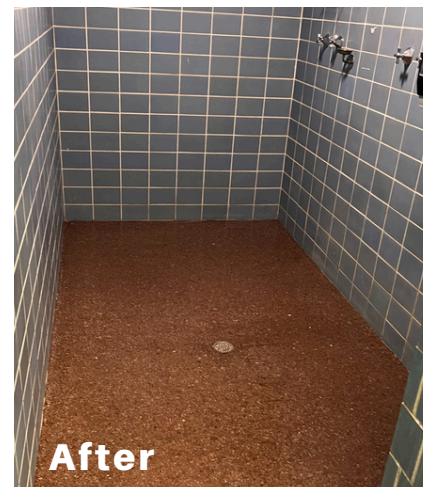
After
